**IN THE DISTRICT COURT
AT AUCKLAND**

**CRI-2021-004-006221
[2023] NZDC 26957**

MARITIME NEW ZEALAND
Prosecutor

PORT OF AUCKLAND LIMITED
Defendant

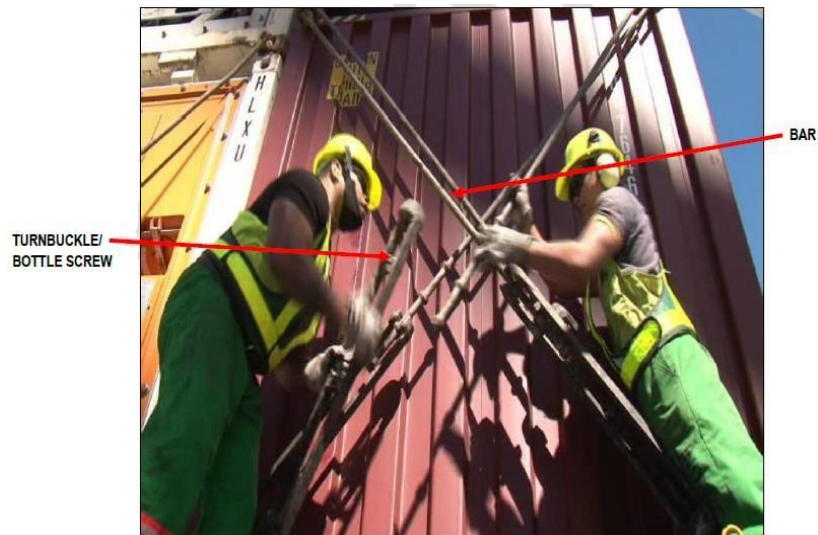
Figure 2: lashers working in pairs showing the components of the lash

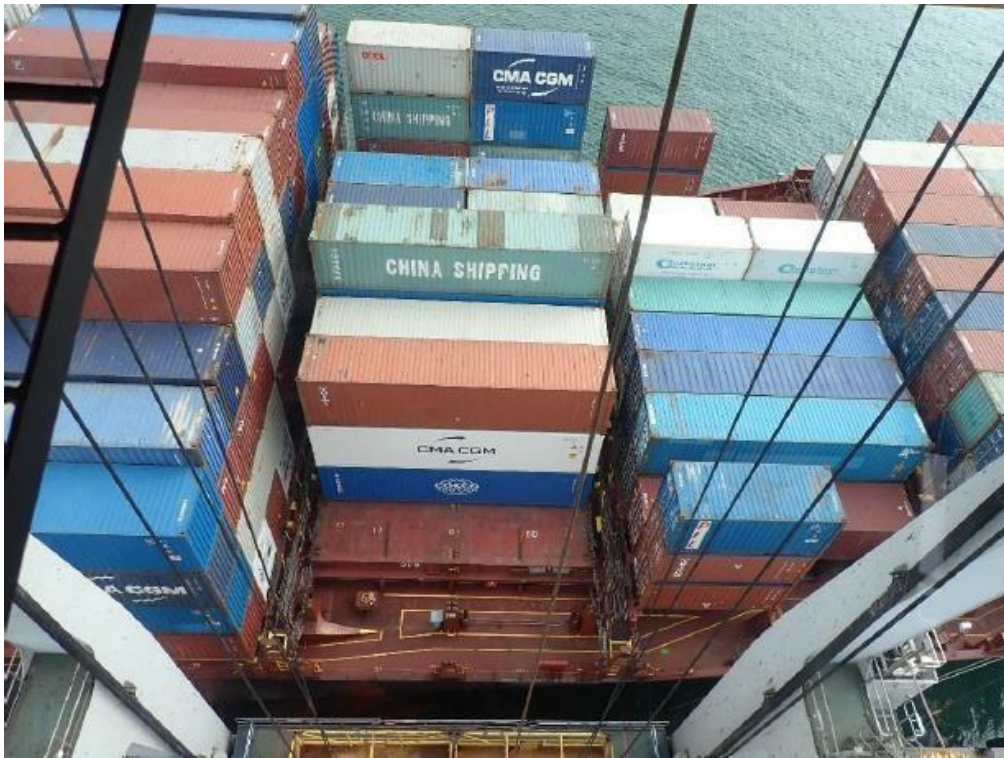
Figure 3: an example of a view looking from crane cab (not incident site)
